# Works Completed during the last week.

**Week 215: Monday 4th January to Friday 8th January 2010.**

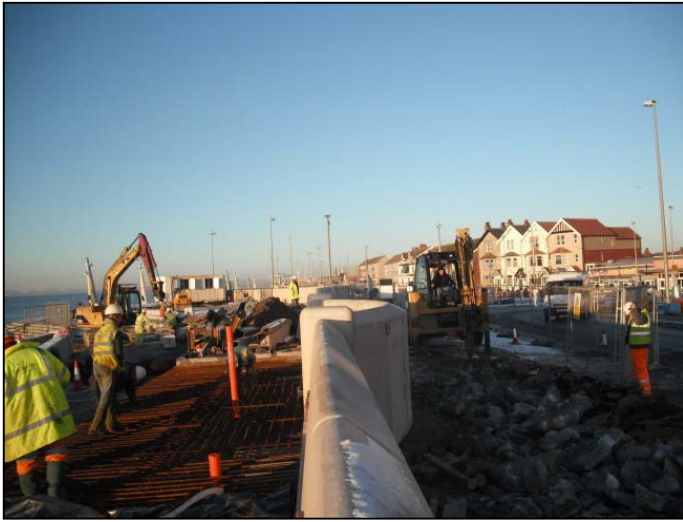
Remaining precast rear units placed and reinforcement to base being fabricated.

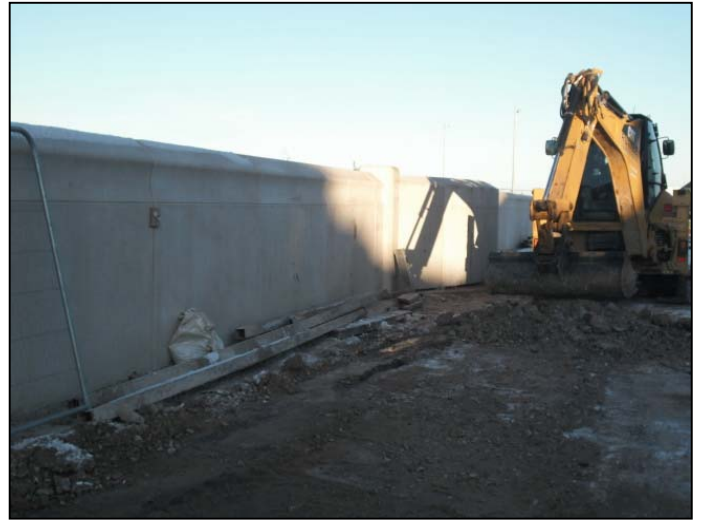
Highway side of completed precast rear wall placement.

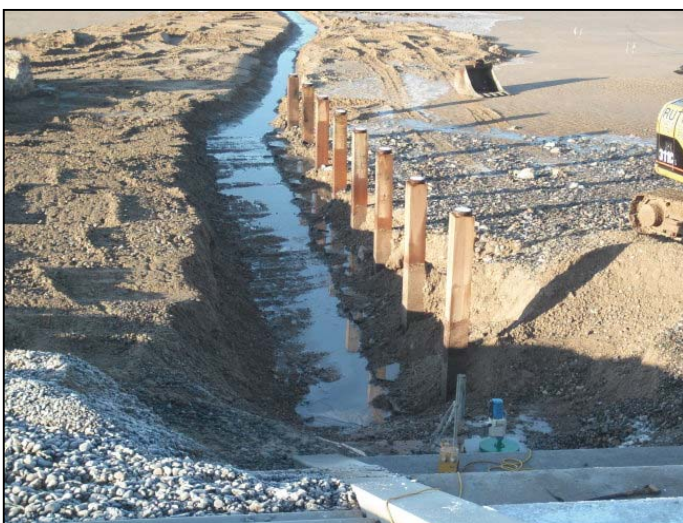
Excavation adjacent to groyne to allow timber works.

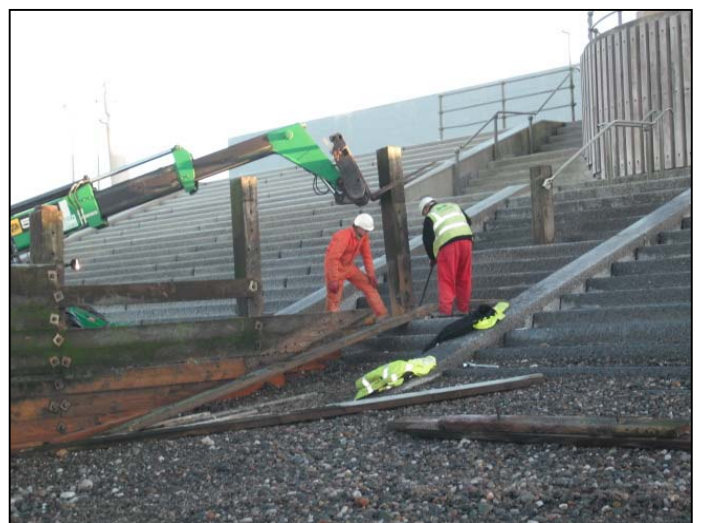
- The revetment groyne posts in the completed phases of works were not fitted in the same manner as described above. Instead the post was fitted into the cored hole and the void between post and hole filled with concrete. Unfortunately, these all lifted during rough weather and became detached. Remedial work commenced this week on repairs to these posts using the steel adaptor bolted to post and revetment described above.

Remedial works to phase 2 groynes.
