Works Completed during the last week.

Week 191: Monday 20 July to Friday 24 July 2009

Birse
Coastal
A Balfour Beatty Company

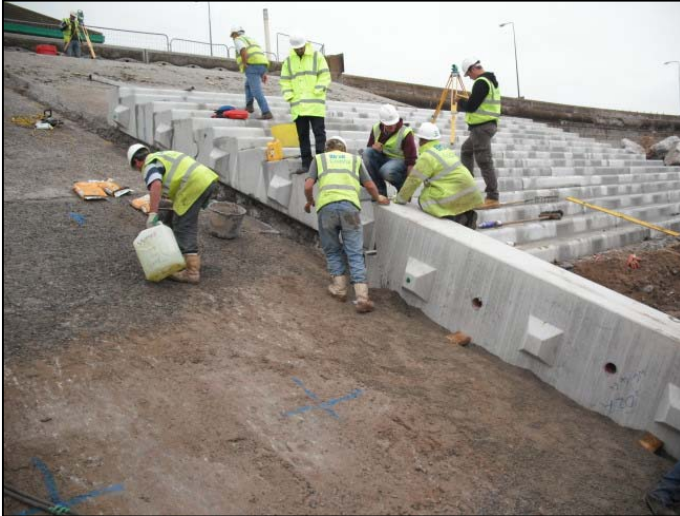
Lower spine beam between panel 9 & 10 being placed.

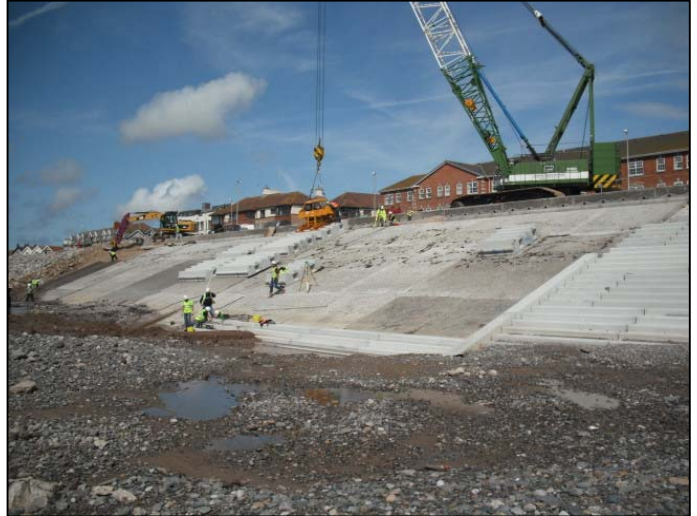
- 9 full units and 3 half units were placed to complete the southern most panel 10 this week. This panel is significantly narrower than a standard bay being only 3 and a half units wide. An additional 13 full units and 1 half units were placed to the lower rows of panel 9 also this week.

Lower row of units being completed in panel 9.

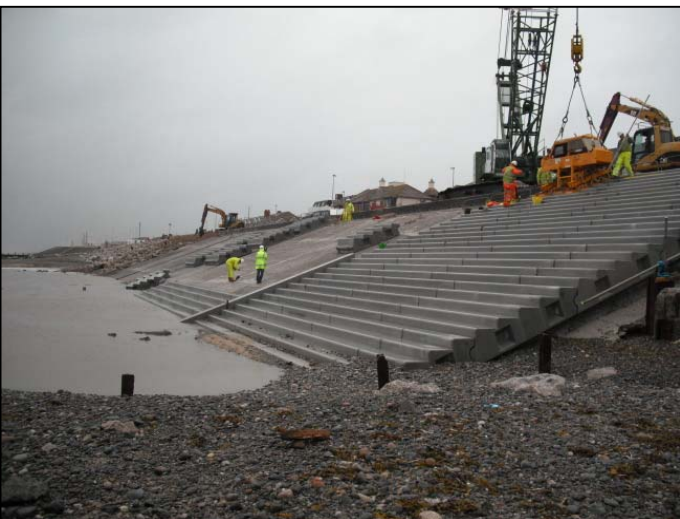
Last revetment unit in top row of panel 10 being placed.

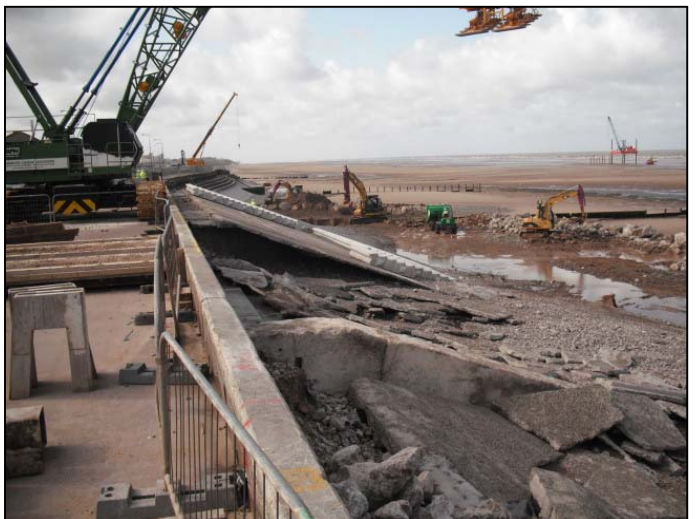
- The new revetment's structural stability is dependant on all elements of the construction being in place together, including the fill, blinding concrete and interlocked precast units. Without the precast units in place the remaining elements are vulnerable to damage from high tides combined with poor weather conditions. It is important that the blinding advances ahead of unit placing but not too far ahead so as to leave large areas open to the elements.
- Unfortunately, high spring tides and unseasonal weather this week damaged and washed out the upper two thirds of fill and blinding concrete to the completed panel 8 and part completed panel 7. Fortunately, the construction of concrete diaphragm walls every 25 metres restricts damage to panel sizes. No further work was carried out on the blinding this week due to the tides and weather.

Panels 7 and 8 completely demolished and washed out.
